KING HOME INSPECTIONS, LLC  
**INSPECTION REPORT**

Property Address

New Jersey

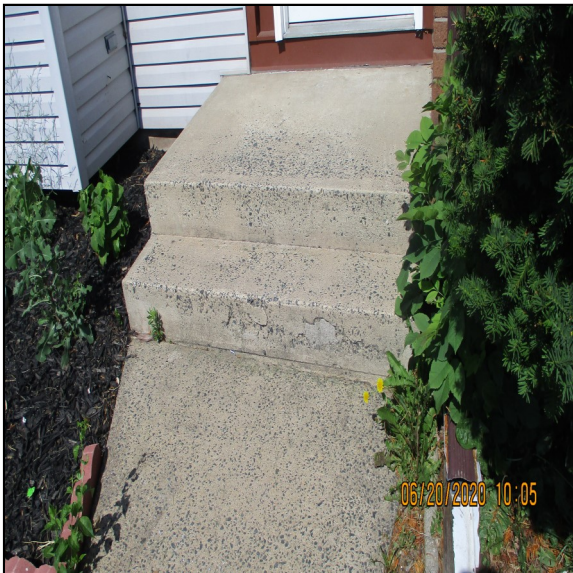
Front sidewalk and stairs. Step should be repaired.

<b>RATING</b>	<b>REMARKS</b>
ENTRANCE DOOR	ACCEPTABLE	
DOORBELL	NOT APPLICABLE	
STEPS	REPAIR/REPLACE	Recommend repairing one step at the front of the house.
Concrete		
GUTTERS/DOWNSPOUTS	REPAIR/REPLACE	The gutters at the front of the house has debris and needs to be cleaned. Recommend a qualified contractor to inspect and clean as needed.
Aluminum		
PORCH	NOT APPLICABLE	
HOSE CONNECTIONS	ACCEPTABLE	
Front and back		
BALCONY	NOT APPLICABLE	
CAR PORT	NOT APPLICABLE	
EXTERIOR PAINTING	REPAIR/REPLACE	The paint on eaves is peeling. Recommend inspection and painting by a qualified individual.

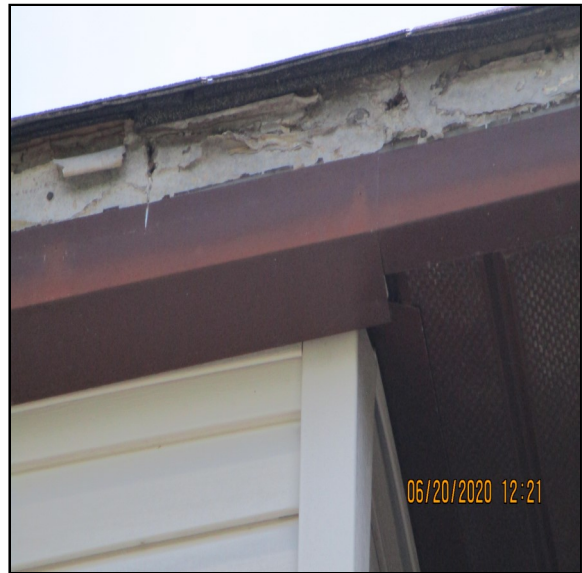
Peeling paint on roof fascia at the back of the house

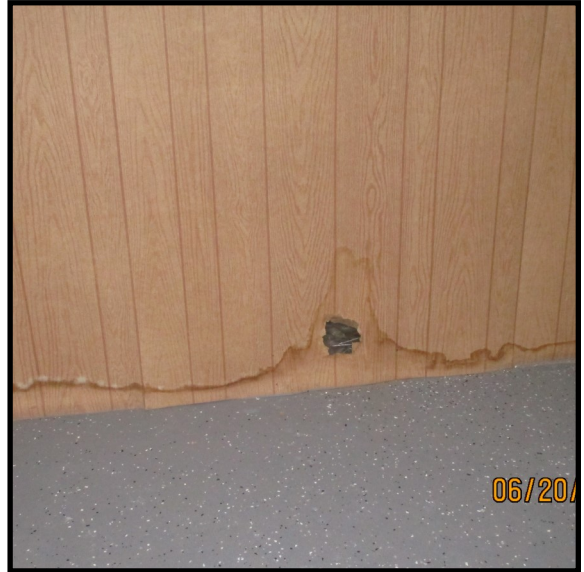
Water damage near sump pump in basement

RATING	REMARKS
FOUNDATION WALLS	REPAIR/REPLACE	Finished basement. Signs of water intrusion in the room where the sump pump is located. A qualified contractor should inspect and repair as needed.
Cinder block		
FLOOR	ACCEPTABLE	
Concrete, Vinyl tiles		
WINDOWS/VENTILATION	SAFETY ISSUE	Poor ventilation, recommend replacing basement windows. A qualified contractor should inspect and repair as needed.
MOISTURE CONDITION	REPAIR/REPLACE	Moisture intrusion in walls where the sump pump is located. Recommend consulting with basement water proofing co. for remediation methods.
LIGHTING/WIRING	SAFETY ISSUE	No ground in outlets. Lights needed above basement stairs.
120V and 240V		
SUPPORT COLUMNS	ACCEPTABLE	Where accessible
Metal, Wood		
FLOOR JOISTS	ACCEPTABLE	Where accessible
Wooden joists		
BEAMS/GIRDERS	ACCEPTABLE	Where accessible
Wood, Metal		
BOX JOISTS/SUB FLOOR	REPAIR/REPLACE	Sub floor in sump pump room needs repair.

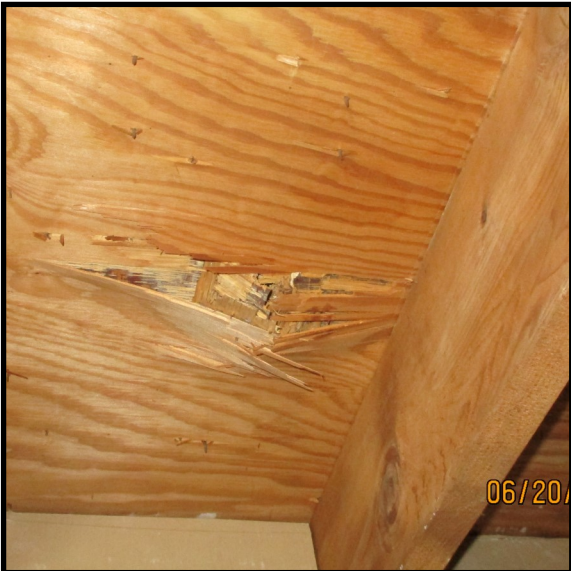
Damaged sub-flooring in basement

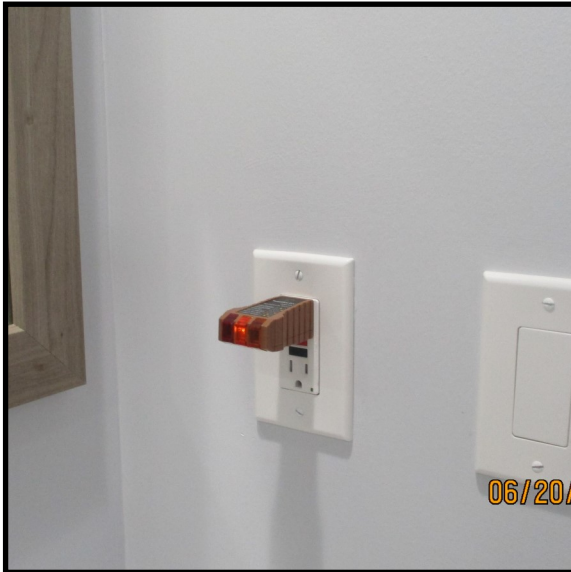
GFCI outlet in bathroom has no ground

1. Outlets in kitchen, bathroom and laundry areas need grounding. A qualified electrician should inspect and repair as needed.
2. The roof asphalt shingles are old and at the end of its life expectancy. Unable to determine if this roof will leak. A qualified roof contractor should inspect and repair as needed.

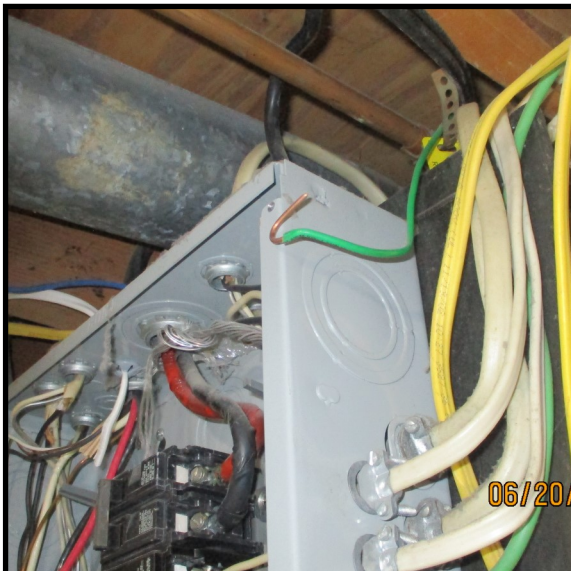
Ground wire is disconnected from main electric panel

RATING	REMARKS
SERVICE ENTRANCE	ACCEPTABLE	
Under ground		
SERVICE BOX / PANEL	<b>SAFETY ISSUE</b>	Neutral wires and ground wires are in the same bars. I recommend a licensed electrician to inspect and correct as needed.
Panel type: circuit breakers Panel capacity: 100 amps Panel location: basement		
AUXILIARY PANEL / SUB PANEL	NOT APPLICABLE	
LIGHTS	ACCEPTABLE	
OUTLETS	<b>SAFETY ISSUE</b>	Outlets in kitchen, bathroom and laundry areas need grounding.
SWITCHES	ACCEPTABLE	
JUNCTION BOXES	ACCEPTABLE

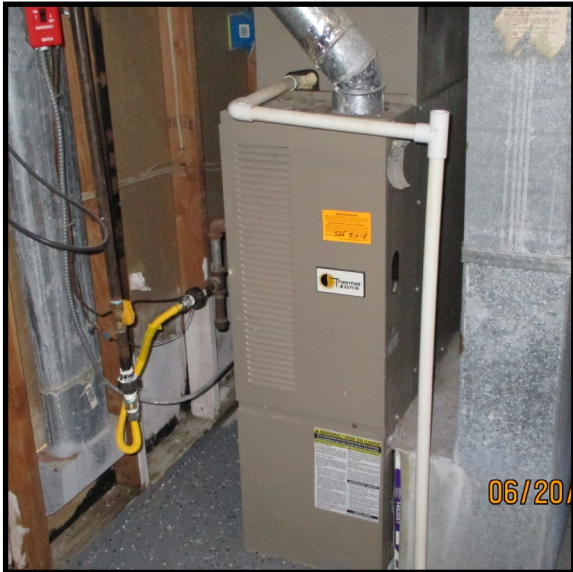
Broken gas furnace

RATING	REMARKS
HEATING	NOT INSPECTED	Regular maintenance is required.
MANUFACTURER: Thermal Zone FUEL TYPE: Gas		No warranty.
HVAC	SAFETY ISSUE	The air conditioner didn't operate and failed to produce cold air. I recommend a licensed HVAC contractor to inspect and repair as needed.
Central unit		
PIPING	NOT APPLICABLE	
THERMOSTAT	ACCEPTABLE	
Digital		
ELECTRICAL VOLTAGE	ACCEPTABLE	
AMPERAGE RATING	ACCEPTABLE	
MAIN DISTRIBUTION PANEL	SAFETY ISSUE	Neutral wires and ground wires are in the same bars. I recommend a licensed electrician to inspect and correct as needed.
Basement		
ELECTRICAL WIRING	SAFETY ISSUE	No ground in GFCI outlets in kitchen, bathroom and laundry areas.
Romex		
GROUNDING WIRE	SAFETY ISSUE	Recommend copper ground wires as ground rod and around water meter.
MAIN OVERHEAD WIRE	NOT APPLICABLE

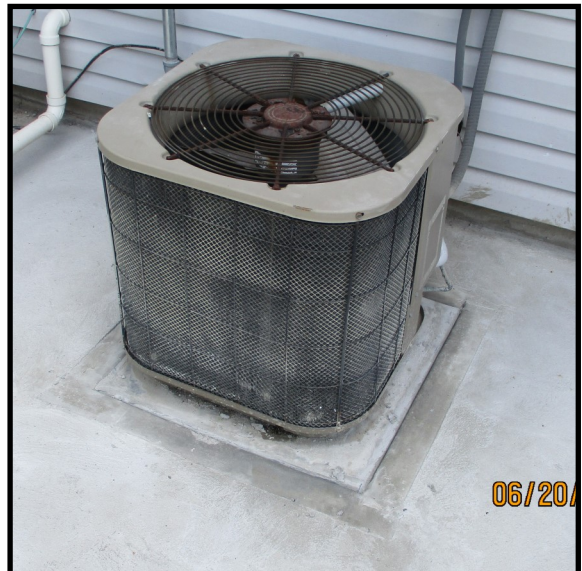
Old AC unit at the back of the house

5. The air conditioner did not operate and failed to produce cold air. I recommend a licensed HVAC contractor to inspect and repair as needed.
6. Recommend elevating water heater 12 inches above floor level and installing electric jumper. The TPR valve needs a 3/4 threaded pipe to extend within 6 inches of floor for safety. PVC pipe is approved for hot water use. I recommend a qualified contractor to inspect and repair as needed.

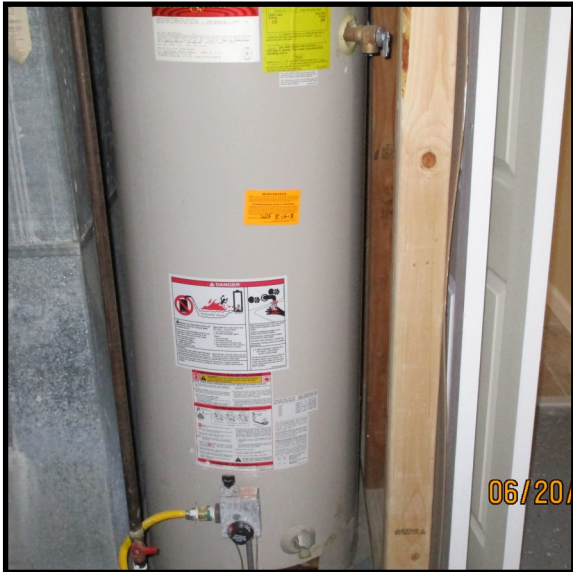
Old water heater

RATING	REMARKS
PLUMBING PIPING	ACCEPTABLE	
PVC, Copper		
PLUMBING CONNECTIONS	REPAIR/REPLACE	Corroded valves due to normal wear and tear. Recommend repairs or replace as necessary.
WATER HEATER	SAFETY ISSUE	Recommend elevating water heater 12 inches above floor level and installing electric jumper. The TPR valve needs a 3/4 threaded pipe to extend within 6 inches of floor for safety. PVC pipe is not approved for hot water use. I recommend a qualified contractor to inspect and repair as needed.
Manufacturer:		
Fuel type:		
Capacity:		
Year made:		
WATER PRESSURE	ACCEPTABLE	
WATER METER	ACCEPTABLE	
Front side of basement

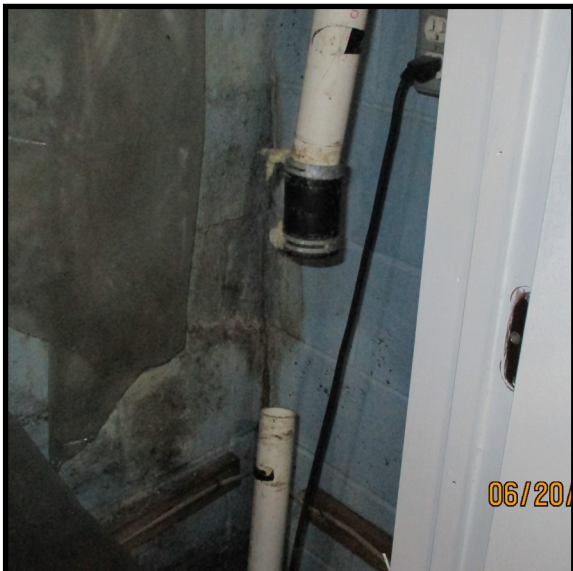
Discharge pipe is disconnected from sump pump

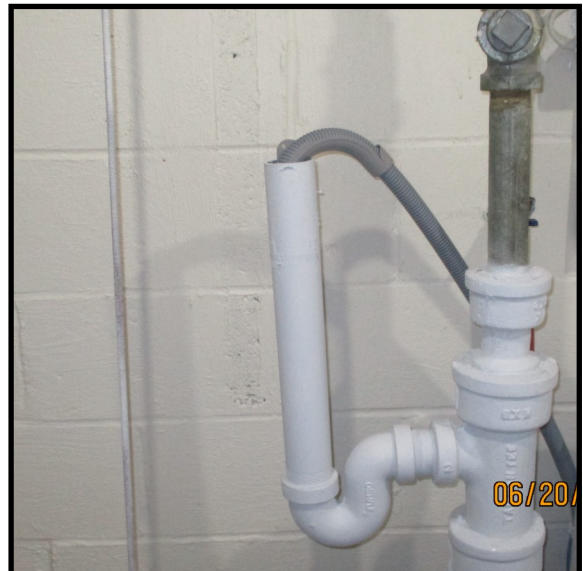
Discharge stuck from washing machine in laundry room

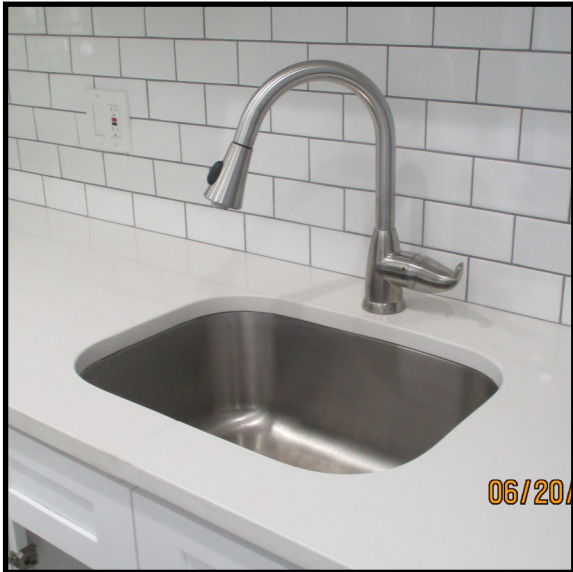
No water in kitchen sink

1. Water is not connected in the kitchen. Recommend a qualified plumber to inspect and repair as needed.
2. Recommend replacing flexible P-Trap to solid P-Trap underneath both bathroom sinks.
3. Laundry room door does not close. A qualified individual is recommend to repair.
4. Roof fan in attic does not work. A qualified contractor should inspect and repair as need.

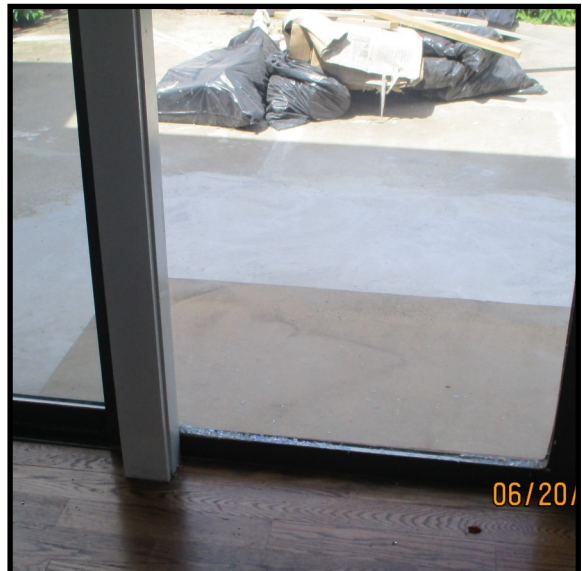
Broken patio entry sliding door in kitchen

RATING	REMARKS
CEILING	ACCEPTABLE	
Drywall		
WALLS	ACCEPTABLE	
Drywall, Ceramic Tile		
FLOORS	ACCEPTABLE	
Wooden panel		
DOORS	SAFETY ISSUE	Patio entry sliding door does not open. A qualified contractor should inspect and repair as needed.
Patio entry		
WINDOWS	REPAIR/REPLACE	Recommend repair.
Metal sliding		
ELECTRICAL OUTLETS	SAFETY ISSUE	No ground in GFCI outlet.
120V		
LIGHTING	ACCEPTABLE	
SINK/FAUCETS	REPAIR/REPLACE	Water is not connected. Recommend a qualified plumber to inspect and repair as needed.
COUNTERS/CABINETS	ACCEPTABLE	
Composite stone		
EXHAUST FAN	NOT APPLICABLE

7. In the kitchen, patio entry sliding door does not open. A qualified contractor should inspect and repair as needed.

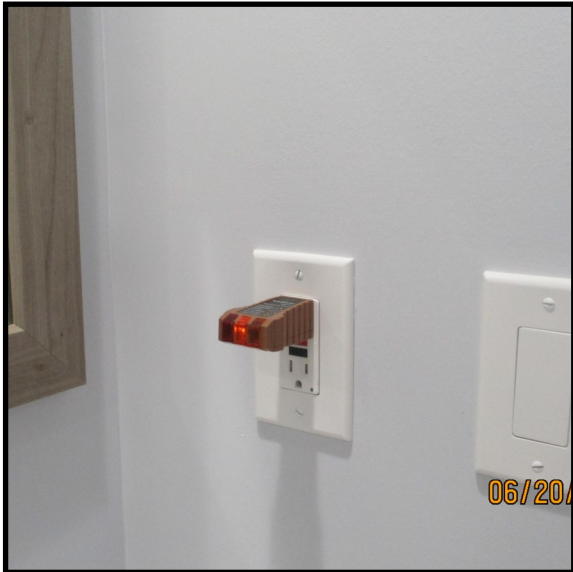
GFCI outlet in bathroom has no ground

<b>RATING</b>	<b>REMARKS</b>
<b>CEILINGS</b>	<b>ACCEPTABLE</b>	
Drywall		
<b>WALLS</b>	<b>ACCEPTABLE</b>	
Drywall, Ceramic tiles		
<b>FLOORS</b>	<b>ACCEPTABLE</b>	
<b>DOORS</b>	<b>ACCEPTABLE</b>	
Hollow		
<b>VENTILATION</b>	<b>ACCEPTABLE</b>	
Exhaust fan		
<b>ELECTRICAL OUTLETS</b>	<b>SAFETY ISSUE</b>	<b>No ground in GFCI outlet.</b>
<b>LIGHTING</b>	<b>ACCEPTABLE</b>	
<b>TILE</b>	<b>ACCEPTABLE</b>

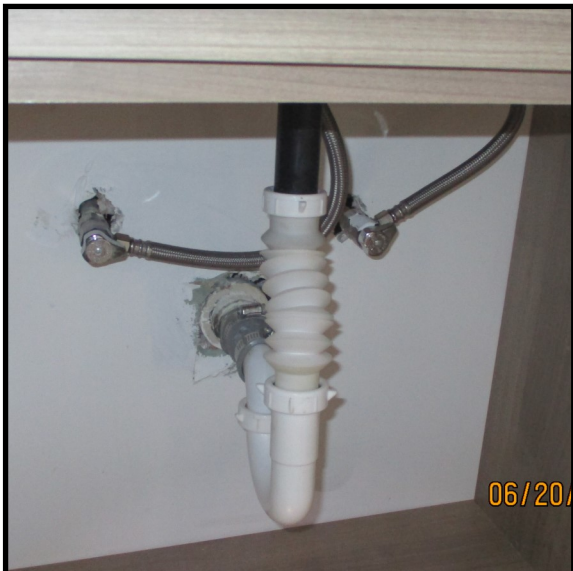
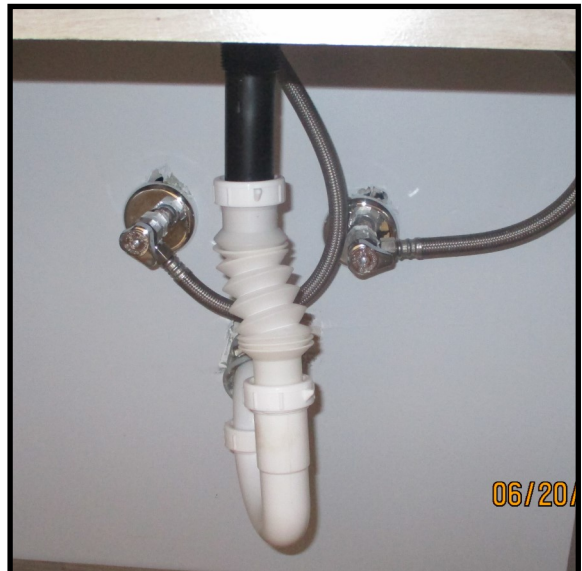
P-Trap underneath sink in 1st bathroom

P-Trap underneath sink in 2nd bathroom

RATING	REMARKS
TUB/SHOWER	ACCEPTABLE	
Fiber glass / Acrylic Ceramic tiles Prefabricated / mortar base		
TOILETS	ACCEPTABLE	
SINK	REPAIR/REPLACE	Recommend replacing flexible P-Trap to solid P-Trap in both bathrooms.
Porcelain, P-Trap		
WATER PRESSURE	ACCEPTABLE

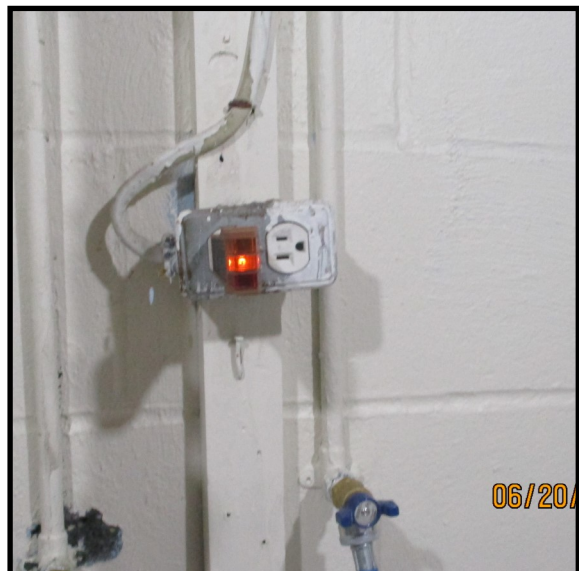
This outlet should be replaced with GFCI outlet

RATING	REMARKS
CEILING	ACCEPTABLE	
Laundry location: basement		
WALLS	ACCEPTABLE	
FLOOR	ACCEPTABLE	
Concrete		
DOOR	REPAIR/REPLACE	Door does not close. A qualified individual should correct as needed.
Hollow		
LAUNDRY ELECTRICAL	SAFETY ISSUE	No ground in GFCI outlet. The nearest outlet is 220 V. Gas dryer needs to be plugged into a 110 V outlet that is out of reach. Recommend a qualified electrician to inspect and correct as needed.
TUB/SINK	ACCEPTABLE	
WASHER/DRYER: LG	ACCEPTABLE	
DRYER VENT	ACCEPTABLE

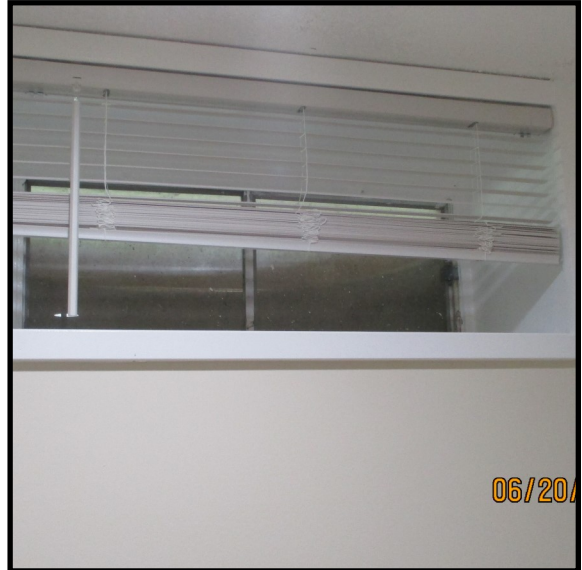
Windows in the basement

3. Poor ventilation, recommend replacing basement windows. A qualified contractor should inspect and repair as needed.
4. Neutral wires and ground wires are in the same bars in main distribution panel. I recommend a licensed electrician to inspect and correct as needed.

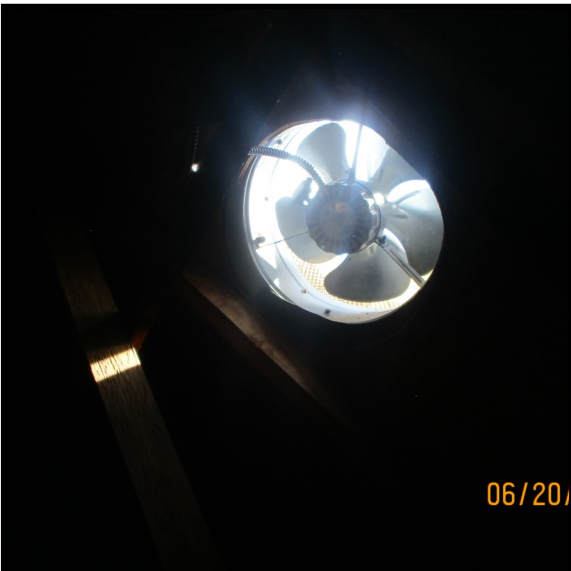
Roof fan in the attic

RATING	REMARKS
ATTIC INSULATION	REPAIR/REPLACE	Recommend adding more insulation, the insulation is about six inches thick. A qualified contractor should inspect and repair as need.
Batt		
ATTIC VENTILATION	REPAIR/REPLACE	Roof fan is not working. A qualified contractor should inspect and repair as need.
Roof fan		
ATTIC SHEATHING	NOT APPLICABLE	
ATTIC ELECTRICAL	NOT APPLICABLE	Recommend installing electric lights.
ATTIC STAIR	NOT APPLICABLE	
ROOF RAFTER/TRUSS	ACCEPTABLE	
FLASHINGS	REPAIR/REPLACE	Chimney flashing needs repair. A qualified roof contractor should inspect and repair as needed.
Metal sheet		
CHIMNEYS	NOT INSPECTED	Chimney Interior Inspection is not part of a Standard Home Inspection. Recommend a level 2 chimney inspection by a licensed & certified co.
Metal Stuck
